PALM STREET WATER PLANT CONDITION ASSESSMENT

City of Huntsville

July 31, 2015

FREESE AND NICHOLS, INC.
11200 Broadway Street
Offices West, Suite 2332
Pearland, TX 77584
832-456-4700

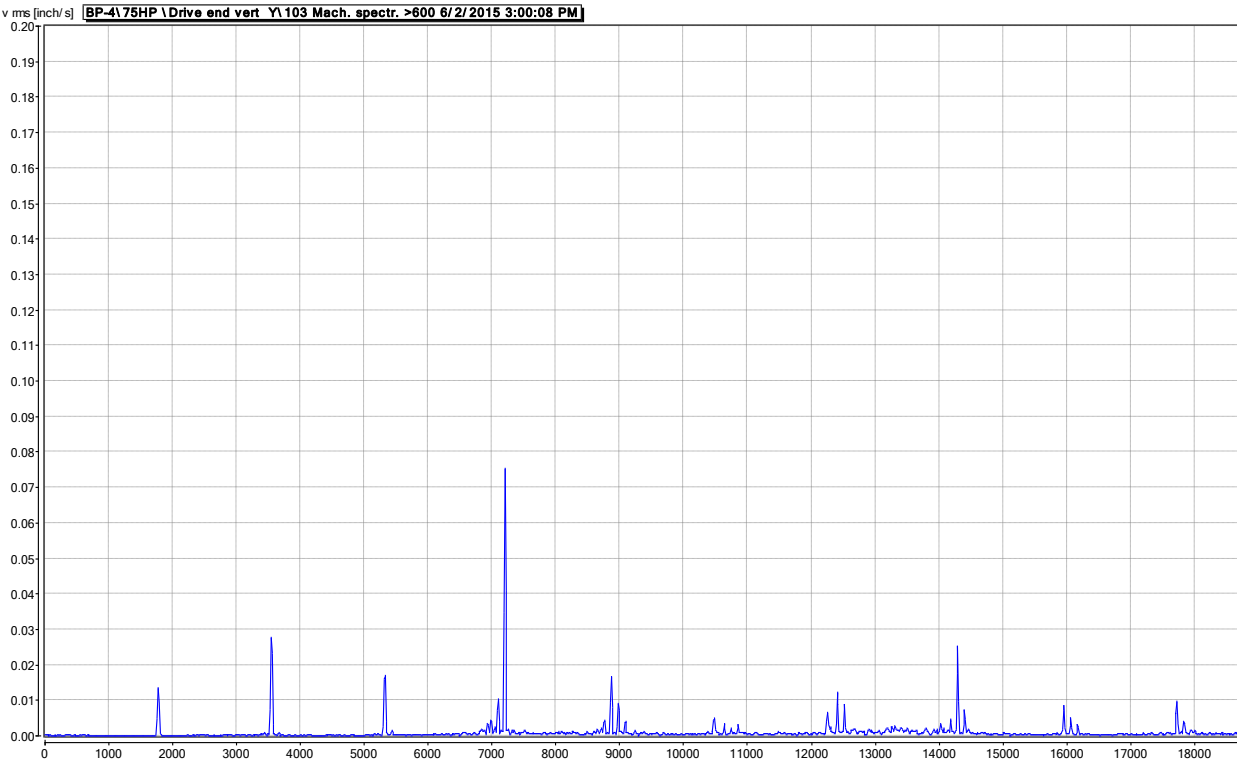
Figure 71: Motor DE-Y Filtered Vibration, highest peak is 0.075 in/sec at 7,200 cpm (4X run speed) with other peaks at 1X, 2X, 3X, 5X, 7X, and 8X

The motor vibration has peaks at 1X up to 7X consistently. This is an indication of looseness in the motor or bearings. The motor should be inspected soon.

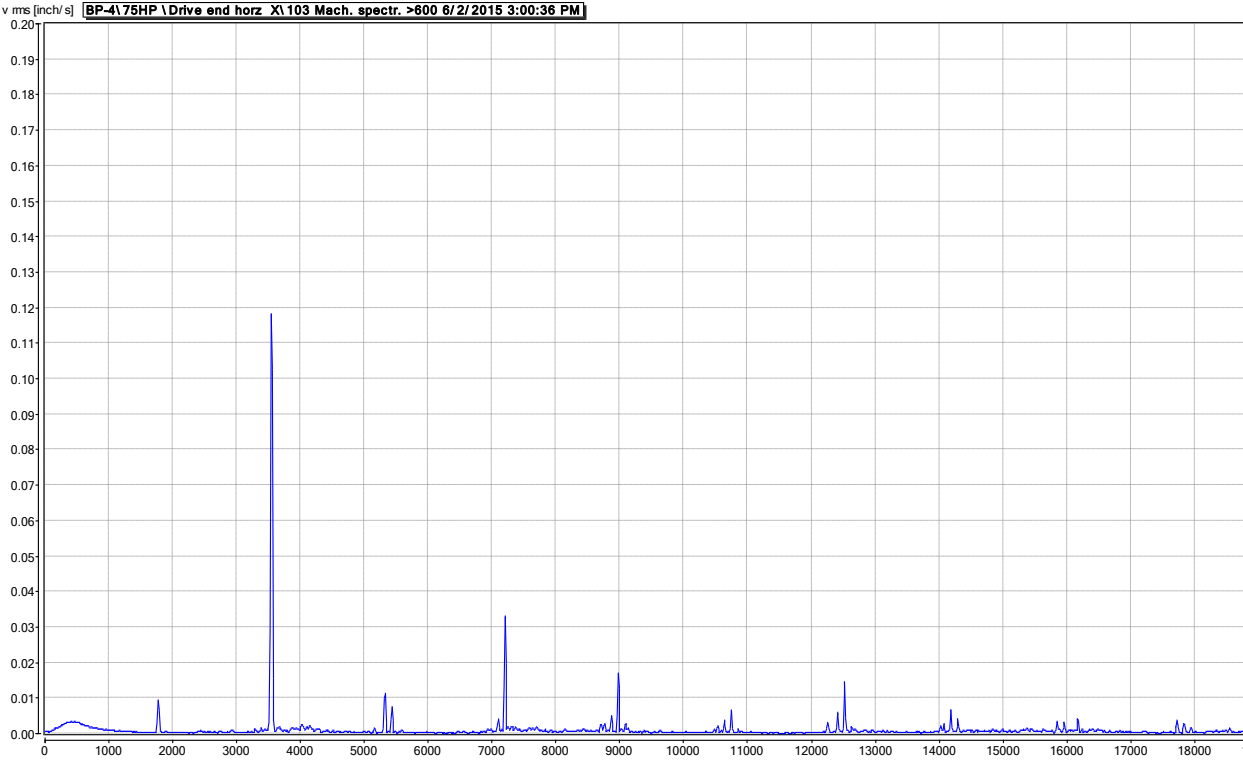
Figure 72: Motor DE-X Filtered Vibration, highest peak is 0.118 in/sec at 3,548 cpm (2X run speed) with other peaks at 1X, 3X, 4X, 5X, and 7X

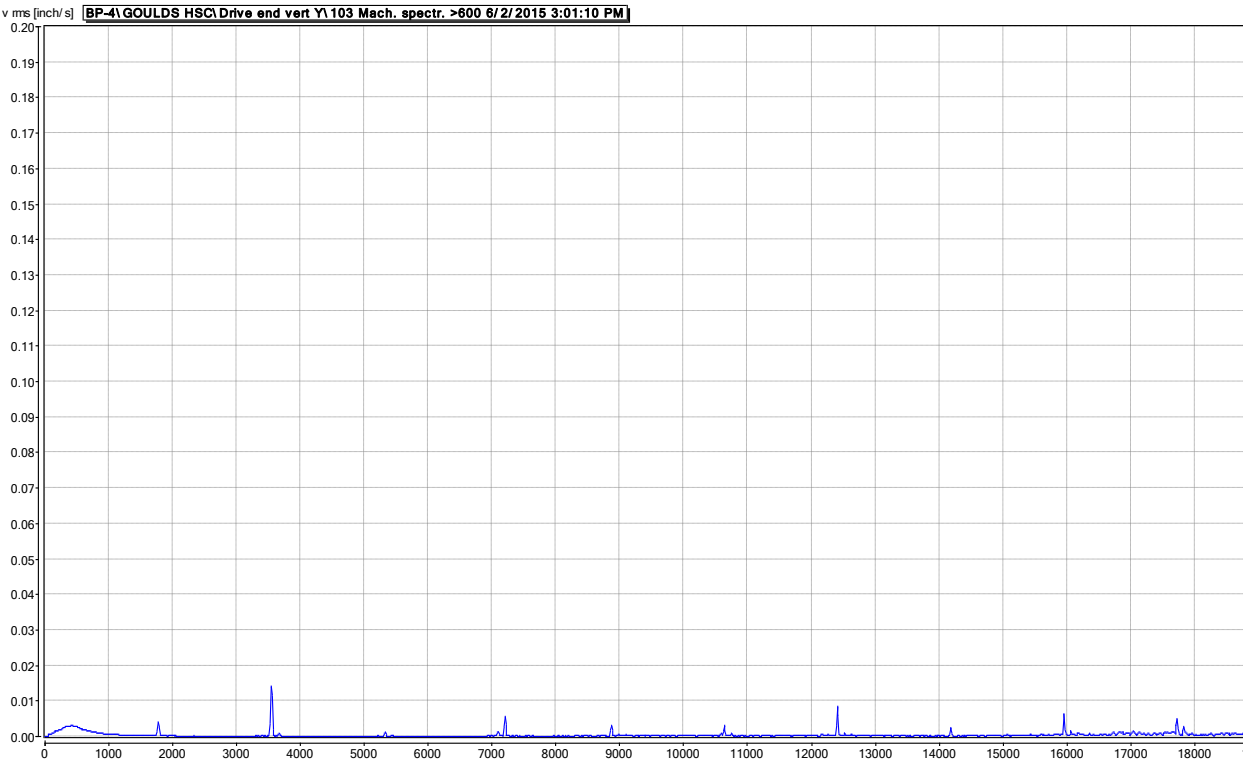
Figure 73: Pump DE-Y Filtered Vibration, all peaks are below 0.015 in/sec

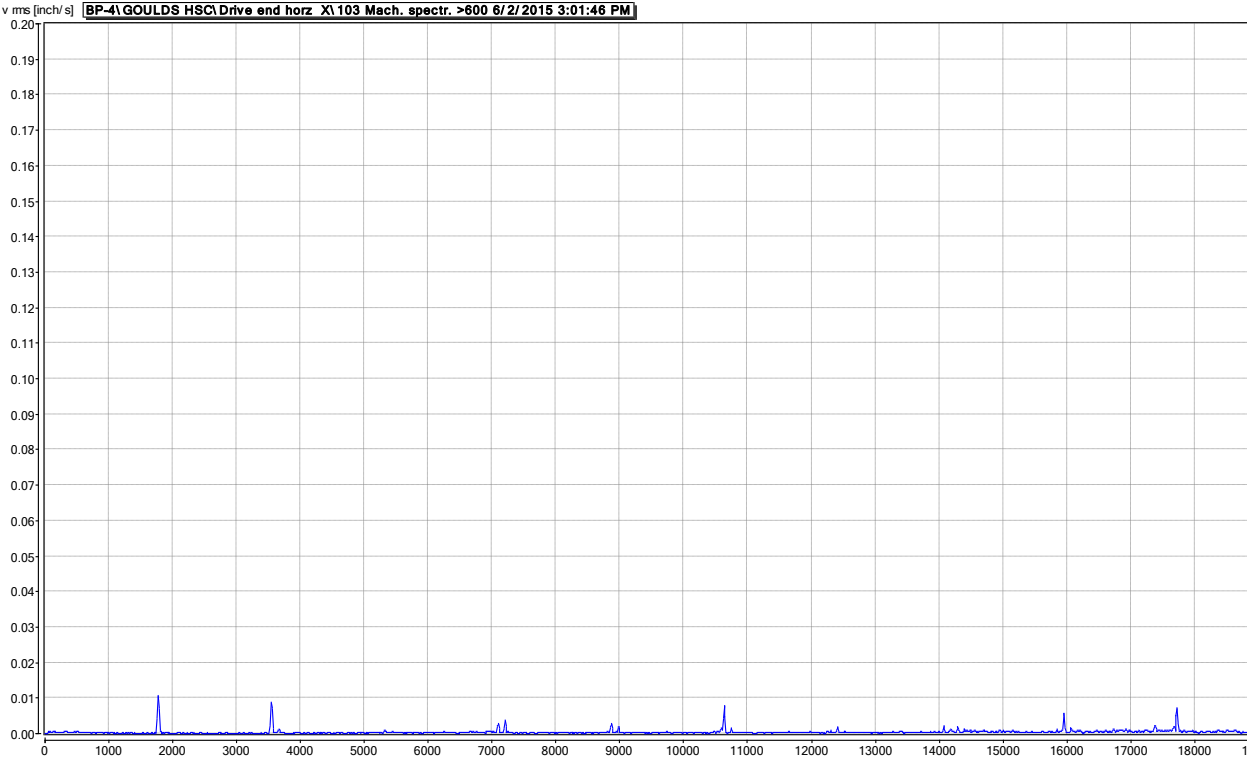
Figure 74: Pump DE-X Filtered Vibration, all peaks are below 0.015 in/sec

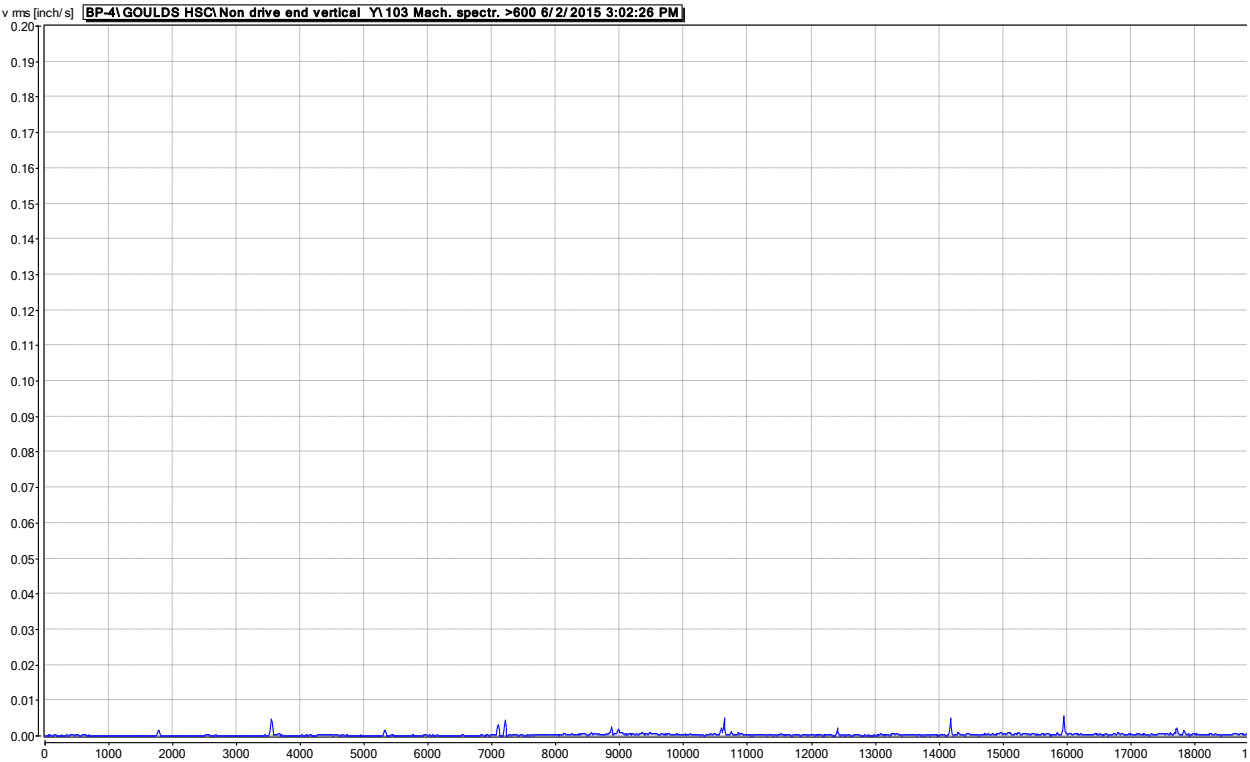
Figure 75: Pump ODE-Y Filtered Vibration, all peaks are below 0.010 in/sec

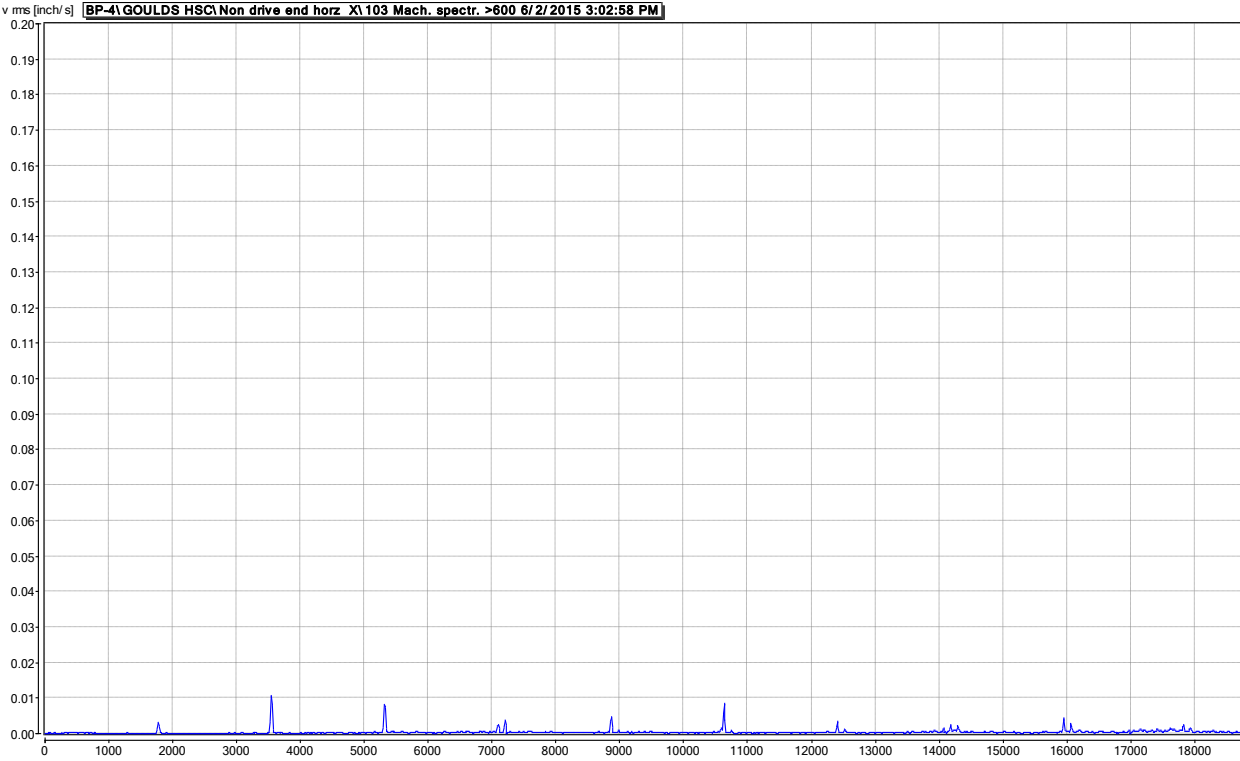
Figure 76: Pump ODE-X Filtered Vibration, all peaks are below 0.015 in/sec

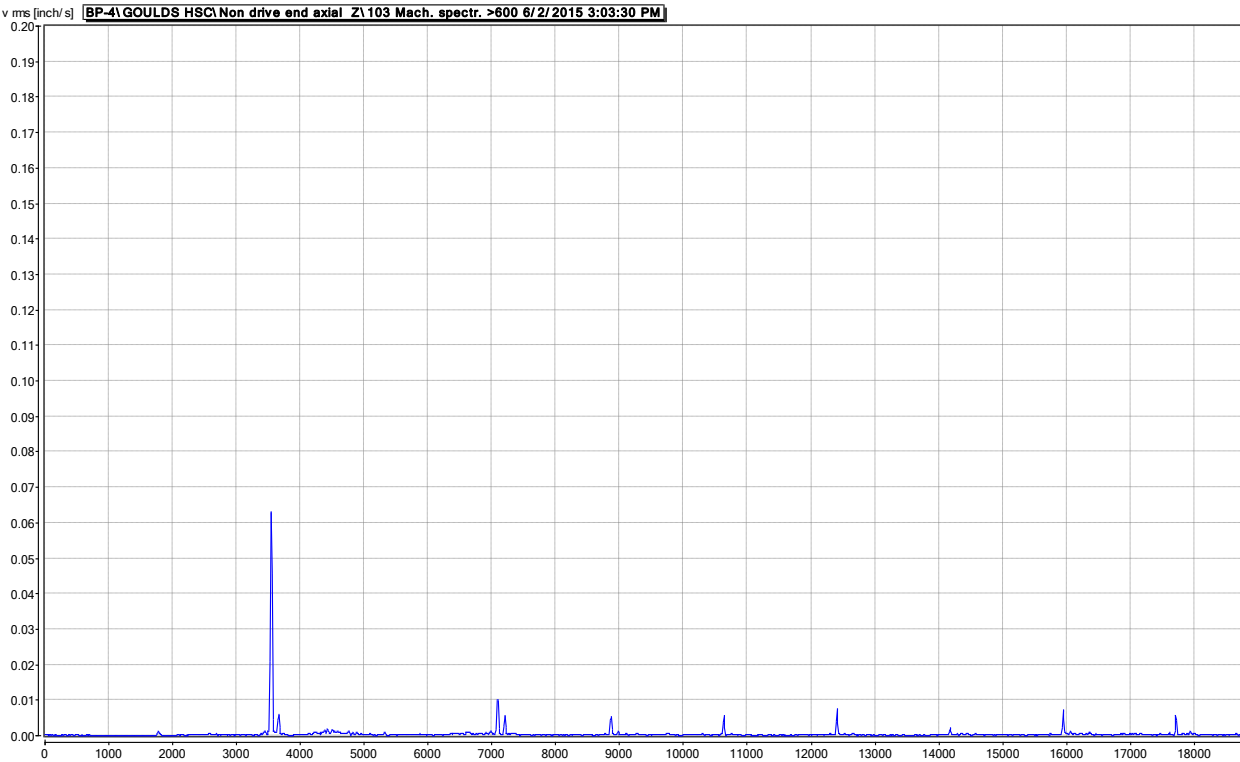
Figure 77: Pump ODE-Z Filtered Vibration, the highest peak is 0.063 in/sec at 3,548 cpm (2X run speed)

The pump vibration is low and has a consistent vibration at 2X which is likely caused parallel and angular misalignment.
